## 12 HEATING & AIR CONDITIONING EQUIPMENT

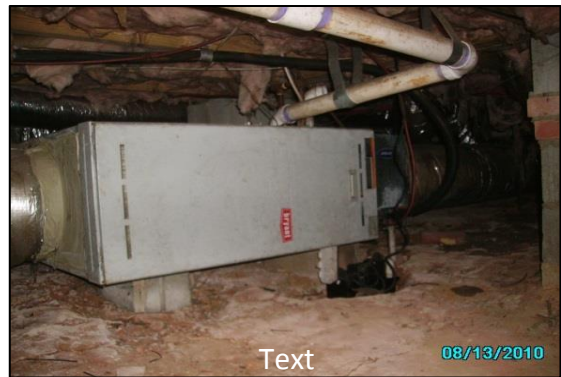
Recommend replacing the air handler in crawl space. Since unit however is functioning, I recommend to first perform a complete duct renovation of the first floor crawl space system. Important to install manual dampers throughout during retrofitting to enable proper air and temperature balancing during final tuneup.
